GENERALIZED MONITORING OF SEASCAPE® INSTALLATION AT CAPE HATTERAS LIGHTHOUSE, NORTH CAROLINA

J. W. Forman

US Army Engineer District, Wilmington
PO Box 1890
Wilmington, North Carolina 28402-1890

February 1986
Final Report

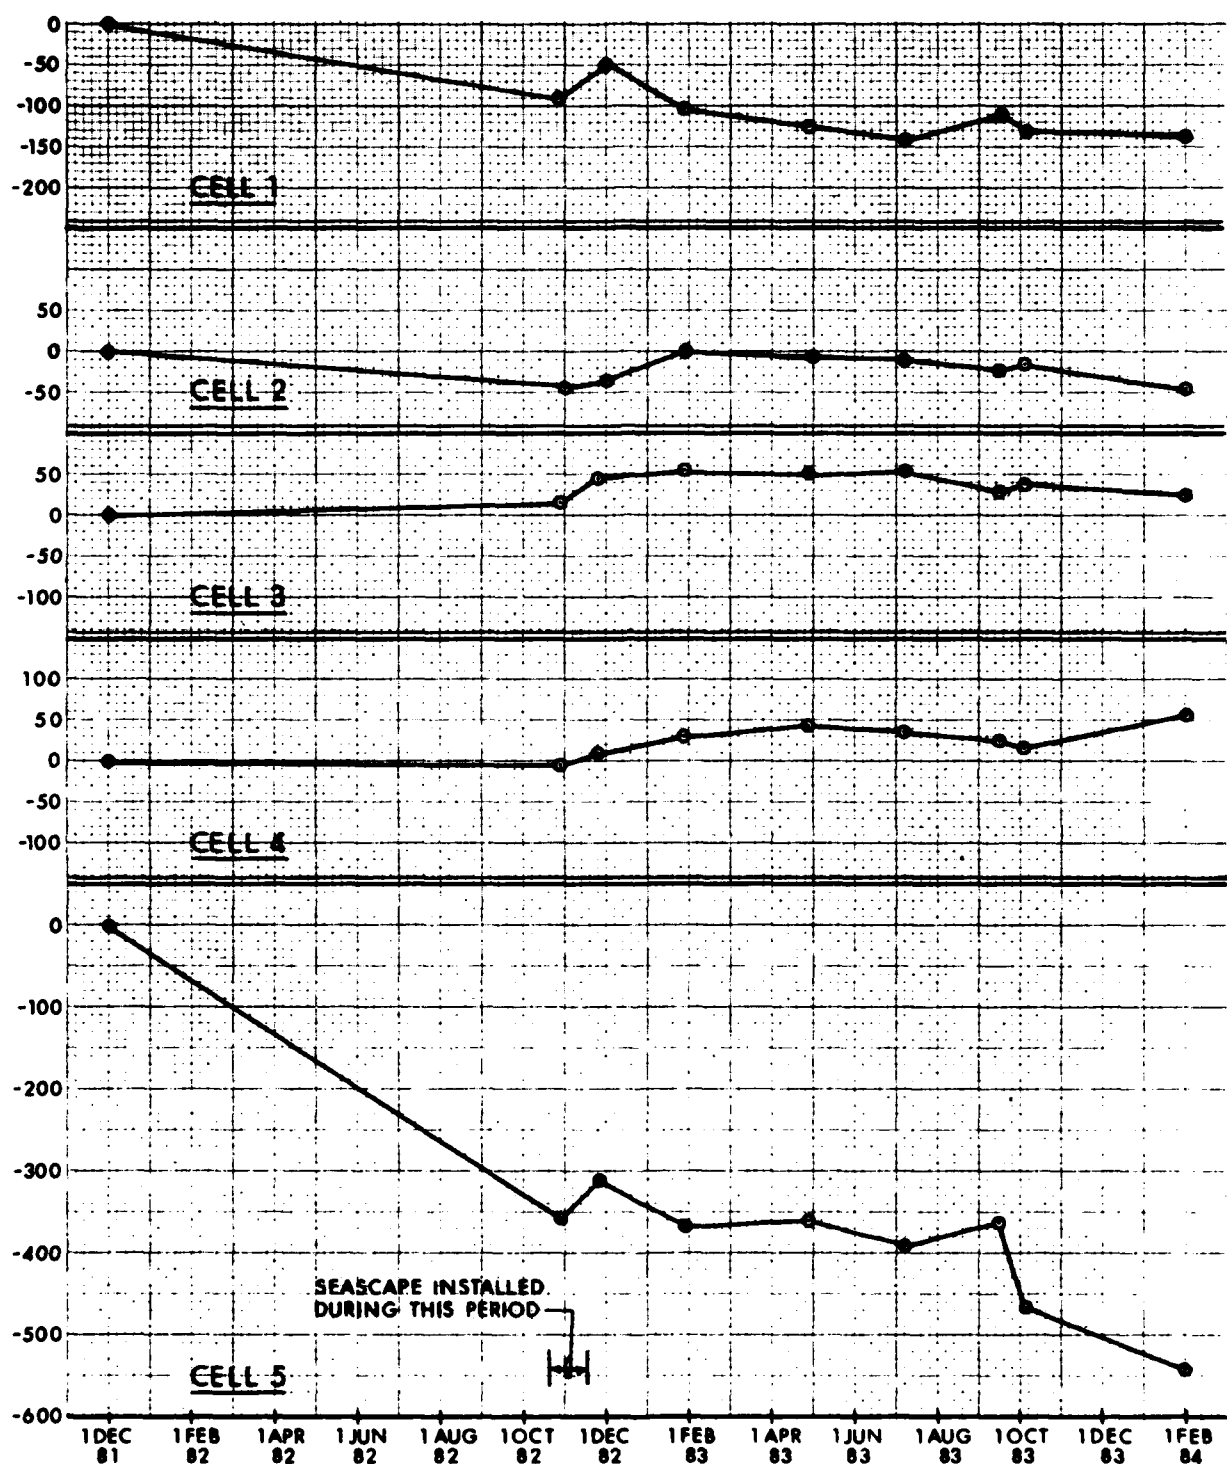
FIGURE 17

The plotted data in figure 17 reveals that, with the exception of the shoreline segments directly affected by the groin field, there is an overall trend of erosion in the study area over the period December 1981 to February 1984. The shoreline segments affected by the groins, cells 3 and 4, experienced a slight accretionary trend during the study period amounting to an average buildup of the shoreline of 25 to 60 feet, respectively.

During and immediately following the installation of SEASCAPE® in October and November 1982, an accretionary trend is apparent over the entire study area. The result is an average buildup of the beach in the study area of 25 feet. Close examination of figures 8 through 13 (Oct 82 through Jul 83) shows a progressive buildup in the southerly direction of the shoreline immediately south of the south groin. This is accompanied by general filling of the shoreline segment between and immediately north of the groins. However, during the accretionary period in cells 2, 3, and 4, the shoreline not directly affected by the groins, cells 1 and 5, experienced a period of fairly rapid erosion amounting to an average shoreline retreat of 80 feet.

AVERAGE SHORELINE POSITIONS IN EACH
STUDY AREA CELL, DECEMBER 1981 TO FEBRUARY 1984
(FROM AERIAL PHOTOGRAPHS)

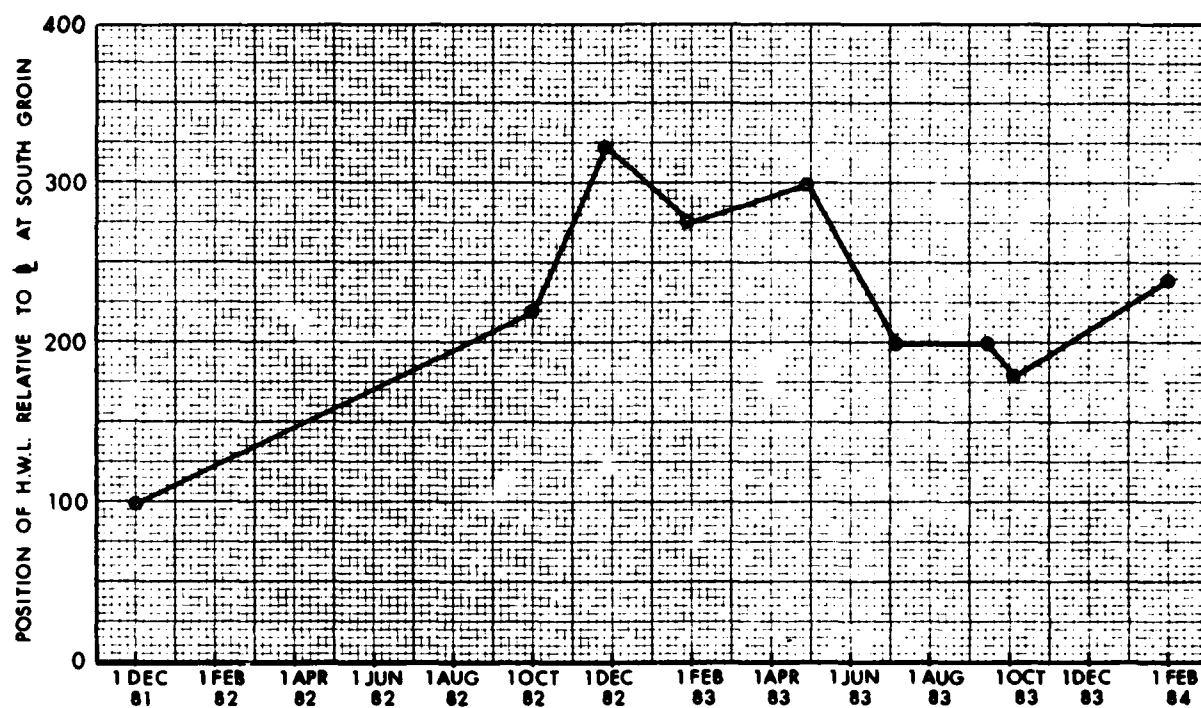
FIGURE 18

Changes in the shoreline position immediately south of the south groin, the area of specific interest in this study, are plotted in figure 18. The position of the shoreline at the south side of the groin measured from the baseline is plotted for each aerial photo date. Comparison with the plots in figure 17 for cells 3 and 4 shows a direct correlation between buildup in the area south of the groin with accretion of the entire shoreline affected by the groin field. This favorable shoreline condition has generally existed throughout the history of the groin field and its attendant impacts on shoreline configuration, with the singular exception of the condition generated by the March 1980 storm which induced a rapid and major temporary retreat of the beach immediately adjacent to and south of the southernmost groin. The fact that the immediate shoreline reach south of the groin field is favorably affected by the groin structures can be attributed to several factors. First, the groin field site is along a section of shore which

SHORELINE POSITION SOUTH OF SOUTH GROIN
AT CAPE HATTERAS DECEMBER 1981 TO FEBRUARY 1984
(FROM AERIAL PHOTOGRAPHS)
